# FIRE SAFETY ALERT: Steelcase LED Shelf Light

October 24, 2024

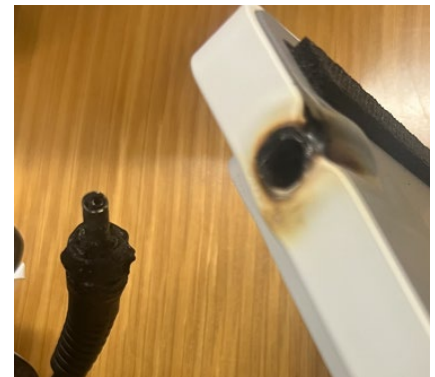
Steelcase LED Shelf Lights:

- **Steelcase LSL18** Standard Light
- **Steelcase LSL18YA** Daisy Chain Starter Light
- **Steelcase LSL18YB** Daisy Chain Secondary Light
- Associated daisy-chain cords
- Associated power cords

Check for Steelcase Shelf Lights LSL18, LSL18YA, LSL18YB and related power cords in your building.

1. Turn the shelf lights off.
2. Disconnect the power cord from the electrical wall outlet. Please be sure to keep cords with the associated light fixture.
3. Document the location of any of these units in your building and note if any heat damage is observed.
4. Report this information to EH&S in the [spreadsheet](#).  
EH&S will follow up to arrange for collection of the light fixtures and to provide more information.
