FIRE SAFETY ALERT: Steelcase LED Shelf Light

October 24, 2024

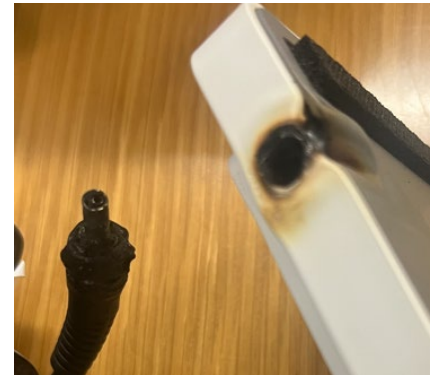
- **Steelcase LSL18** Standard Light
- **Steelcase LSL18YA** Daisy Chain Starter Light
- **Steelcase LSL18YB** Daisy Chain Secondary Light
- Associated daisy-chain cords
- Associated power cords

1. **Turn off** the shelf lights.
2. **Disconnect the power cord** from the electrical wall outlet. Please be sure to keep cords with the associated light fixture.
3. **Document the location** of any of these lights in your building and note if any heat damage is observed.
4. Coordinate with your facility manager/building coordinator to **report this information to EH&S in the [spreadsheet](#)**.
